Road Damage Analysis on Inter-City Roads Using Pavement Condition Index (PCI) Approach in West Java Indonesia

Ahmad Taufik, Suparman, Agus Kosasih, Ohan Farhan, Mira Lestira Hariani

Universitas Swadaya Gunung Jati Cirebon, Indonesia
Email: ohan.farhan@ugj.ac.id ; mira.hariani0103@ugj.ac.id

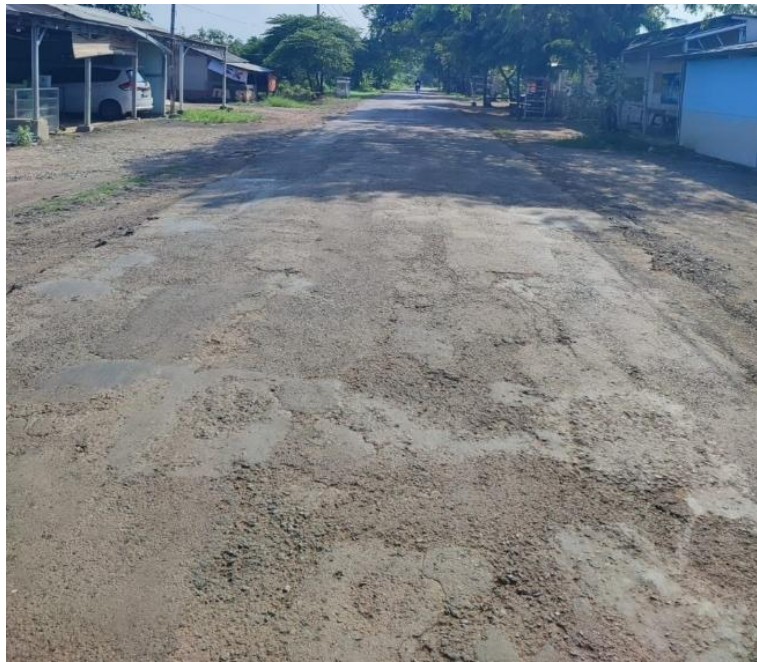
Figure 3. Jangga – Cikamurang Road Condition

Visual observation results show that the road surface has experienced several types of damage with varying degrees of severity. The types of damage identified include alligator cracks, longitudinal/transverse cracks, potholes, bumps and humps, lane/shoulder drop off, and depressions at certain points. Depression damage is characterized by a fairly striking decrease in the elevation of the road surface, which is generally caused by weak subgrade structures or disturbances in the drainage system. In addition, the condition of the unpaved roadside and the drainage system that is not functioning optimally accelerate the damage process, especially during the rainy season.

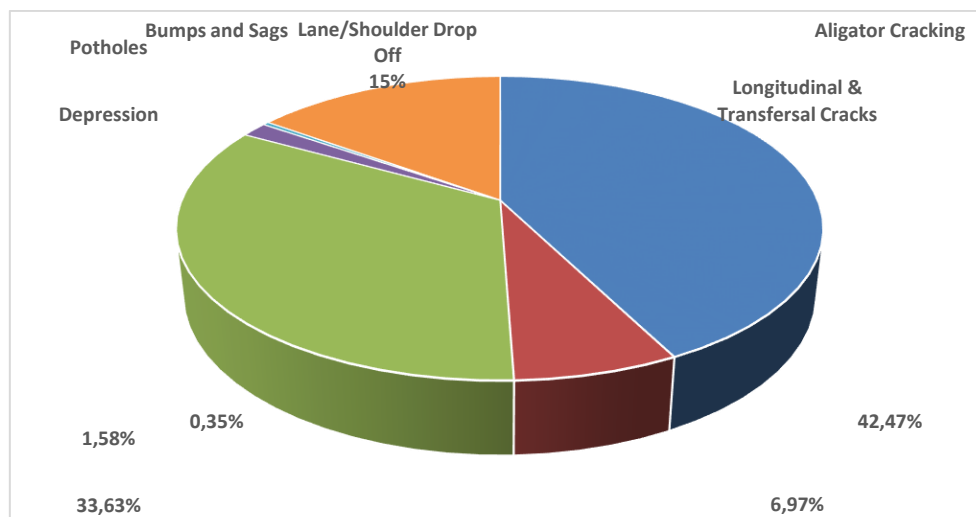
Figure 4. Damage Type of Jangga – Cikamurang Road

The results of the visual field survey showed that the damage to the pavement surface on the Jangga-Cikamurang Road section consisted of various types, dominated by alligator cracking (42.47%) and depression (33.63%). Other types of damage identified were lane/shoulder drop off (15%), longitudinal and transversal cracks (6.97%), potholes (1.58%), and bumps and sags (0.35%), as shown in **Figure 4**. Alligator cracking damage indicates structural fatigue in the pavement layer due to repeated heavy traffic loads, while depression damage reflects the subsidence of the road surface layer due to weak subgrade bearing capacity and poor drainage system. These two types of damage contributed more than 75% of the total damage observed, indicating significant structural degradation in most road sections. Lane/shoulder drop off damage, which covered 15% of the total damage, indicated a difference in elevation between the shoulder and the main traffic lane, which could cause safety problems. Meanwhile, longitudinal & transversal cracks indicate cracks due to thermal expansion or structural movement, although in a smaller proportion. Although the proportion of potholes and bumps and sags damage is relatively small, their presence is still significant because they can develop into more serious damage if not handled immediately. Overall, these results show that the pavement on the Jangga-Cikamurang Road section experiences complex structural stress and requires appropriate maintenance actions according to the type of damage. Large amounts of depressed damage also have an impact on driving comfort and have the potential to cause waterlogging during the rainy season, which further accelerates the rate of road damage. This phenomenon is in line with the findings of (Hasibuan & Surbakti, 2019) and (Aman et al., 2023) that surface depreciation in tropical climates is often caused by water immersion and weak bearing capacity of the subgrade. Overall, the dominance of depressive damage and high severity at several points indicate that the structural condition of the road has experienced

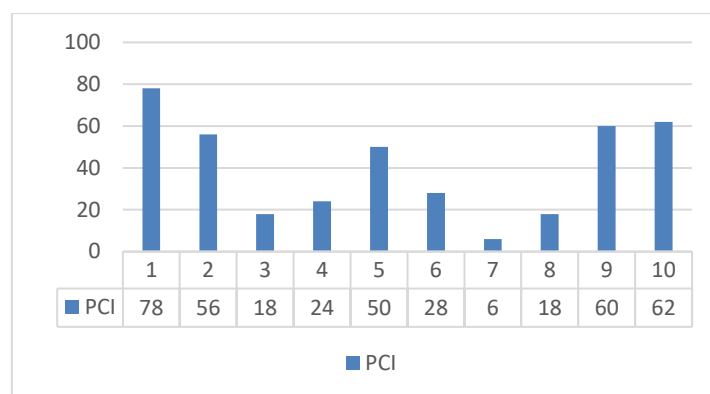
Figure 5. PCI Value on Jangga – Cikamurang Road

shown in **Table 2**, while the distribution graph of PCI values between segments is presented in **Figure 5**. The results of the analysis show that the PCI values on 10 road segments vary from 6 to 78, reflecting variations in the level of damage between locations. Based on the PCI standard classification (ASTM D6433), the road conditions in these segments can be categorized as follows:

1. Satisfactory: 1 segment (Segment 1, PCI = 78)
2. Fair: 3 segment (Segment 2, 9 and 10, PCI = 56, 60 and 62)
3. Poor: 1 segment (Segment 5, PCI = 50)
4. Very Poor: 1 segment (Segment 6, PCI = 28)
5. Serious: 3 segment (Segment 3, 4 and 8, PCI = 18, 24 and 18)
6. Failed: 1 segment (segment 7, PCI = 6)

Figure 5 illustrates the PCI value per segment in the form of a bar chart, which makes it clear that Segment 7 is segments with the worst pavement conditions. This is in line with previous findings that these segments have a significant area of depressive damage, with a high level of severity.

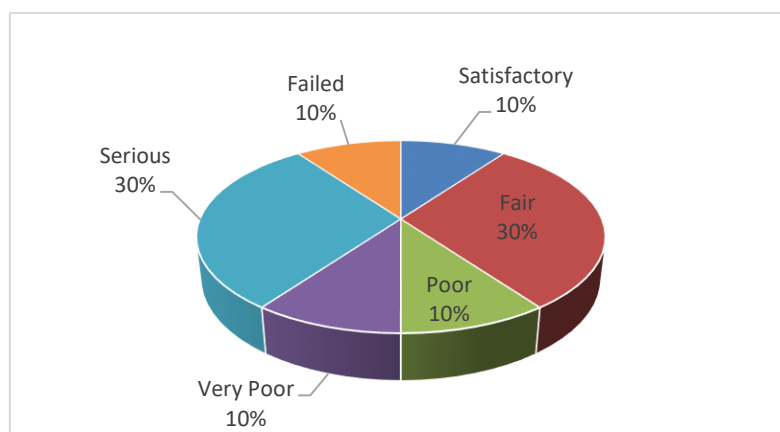
Figure 6. Damage Condition on Jangga – Cikamurang Road

Next, **Figure 6** presents the percentage distribution of pavement condition classification based on PCI value. From the graph, it can be seen that 10% of segments are in failed condition, 10% of segments are categorized in Poor condition, 10% in Very Poor condition, 30% in Serious condition, 30% in Fair condition, and only 10% in Satisfactory condition. The dominance of the classifications "failed", "Poor", "Very Poor", and "Serious" indicates that most road segments experience structural and functional damage that requires immediate maintenance action. In general, the relatively low PCI values in most segments indicate that the quality of the road pavement in this section is in an inadequate condition for long-term service. These results can be the basis for determining maintenance priorities and allocating resources more precisely.

Analysis of the Pavement Condition Index (PCI) values on the Jangga–Cikamurang Road section shows that in general, the pavement conditions on the studied road segments are of varying quality, with the majority tending to be in the poor category. Of the 10 segments studied, only one segment was categorized as being in satisfactory condition (PCI = 78), while the rest were spread across the fair, poor, very poor, serious and failed categories, as shown in **Figure 6**.
