Evaluation of The Drainage System on Jalan Gunung Guntur, Harjamukti District, Cirebon City

Universitas Swadaya Gunung Jati, Cirebon, Indonesia

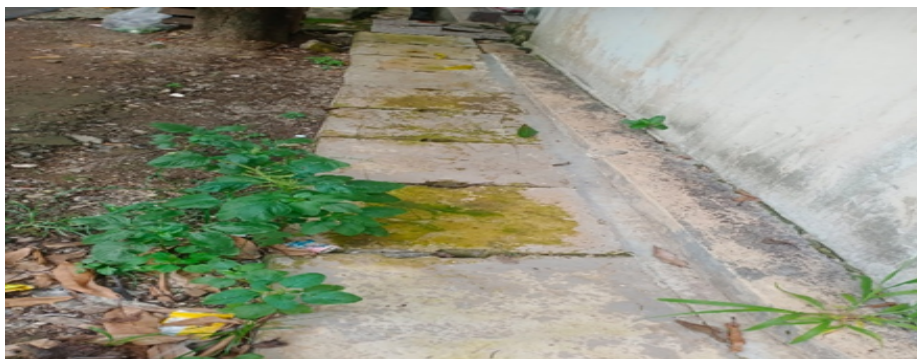
Based on a field survey conducted on Jalan Gunung Guntur, Harjamukti District, it was found that the existing drainage system consists of open channels made of mixed materials and some soil. The drainage channels function to channel rainwater from residential areas and roads to drainage channels. However, in several locations, these channels were found to be poorly maintained, with sedimentation, wild vegetation growth, and piles of garbage obstructing the flow of water (Yang & Zhang, 2021).

The dimensions of the existing channels vary, both in width and depth, resulting in uneven flow capacity. Furthermore, the channel bed slope is relatively small because the study area is located on flat topography. This condition results in low flow velocities and tends to trap rainwater within the channels. During heavy rain, the drainage channels often overflow, causing water to pool on the road and surrounding residential areas. The dimensions of the existing drainage channels in the residential area on Jalan Gunung Guntur, Harjamukti District, Cirebon City, are 0.75 m wide and 0.5 m high (Hardjosuprpto, 1998).

Figure 2. shows the drainage channels that function as rainwater and surface runoff channels. The existence of these drainage channels is very important to prevent water pooling on surfaces and roads and to ensure that the air conditioning system in the surrounding area functions properly.

Figure 2. Condition of existing drainage channels

Factors contributing to the channel's inability to accommodate air discharge include small channel dimensions, lack of routine maintenance, and changes in land use around the study site that increase surface runoff. Therefore, improvements and capacity improvements are necessary to ensure the drainage system functions properly (Piadeh, Behzadian, & Alani, 2022).
